AUDIT REPORT

Audit of engineering and construction activities in MONUC

4 April 2008

Assignment No. AP2006/620/08

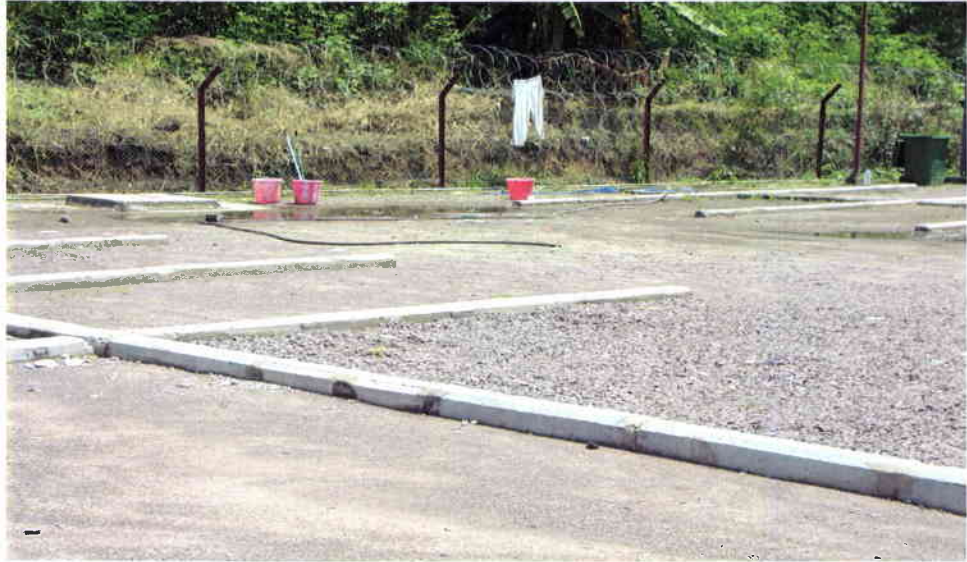
21. The work was substantially completed in September 2006. However, OIOS' site inspection identified a number of deficiencies. For example, the edges of some of the reinforced concrete cement curbs separating the parking spaces were broken and the joints were not properly filled with cement and cured as seen in the picture below. An adequate slope had not been provided for drainage of rain water and not all areas were evenly compacted as required by the scope of work.

Photograph 1: Example of poor quality work

22. The work was neither satisfactorily executed by the contractor as spelled out in the agreement nor was it adequately supervised by the Mission to detect deficiencies.

(4) The MONUC Administration should adopt a formal planning and management system to effectively supervise and monitor construction work to ensure quality work is executed by contractors.

24. *The MONUC Administration accepted recommendation 4 and stated they would formalize its practices relating to work undertaken by the contractors and develop an SOP for Site Engineers in MONUC. The MONUC added that the management of the Onatra car park project involved formal site meetings and written instructions to the vendor through Procurement Section. The quality issues raised in the audit were addressed as the vendor was not paid for the defects mentioned. Recommendation 4 remains open pending receipt of a copy a SOP for Site Engineers in MONUC.*
