# RUNWAY FRICTION CHARACTERISTICS EVALUATION

**Diego Garcia, BIOT**

June 2004

RUNWAY FRICTION CHARACTERISTICS EVALUATION OF  
DIEGO GARCIA, BIOT

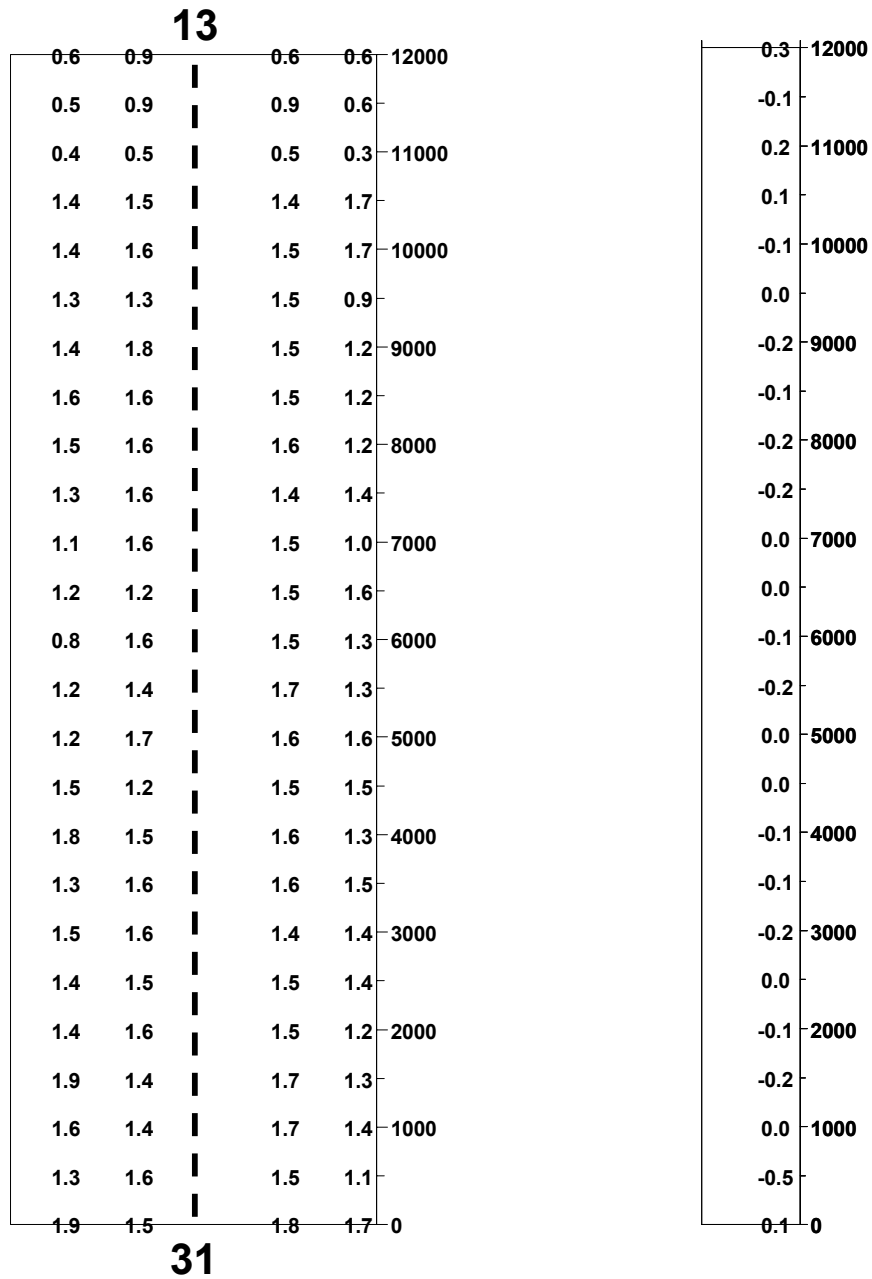
## SLOPE MEASUREMENTS

- a. Runway 13/31: The runway is 200 feet wide. The runway is crowned from the center to the outer edges with slopes ranging from 0.3 to 1.9% and 85% of the transverse slopes are greater than or equal to the 1% recommended minimum. The longitudinal slopes range from -0.5 to 0.3%.
- b. Parallel Taxiway: The taxiway is 175 feet wide. The taxiway is crowned from the center to the outer edges with slopes ranging from -1.7 to 1.7% and 55% of the transverse slopes are greater than the 1% recommended minimum. The longitudinal slopes range from -0.7 to 0.6%.

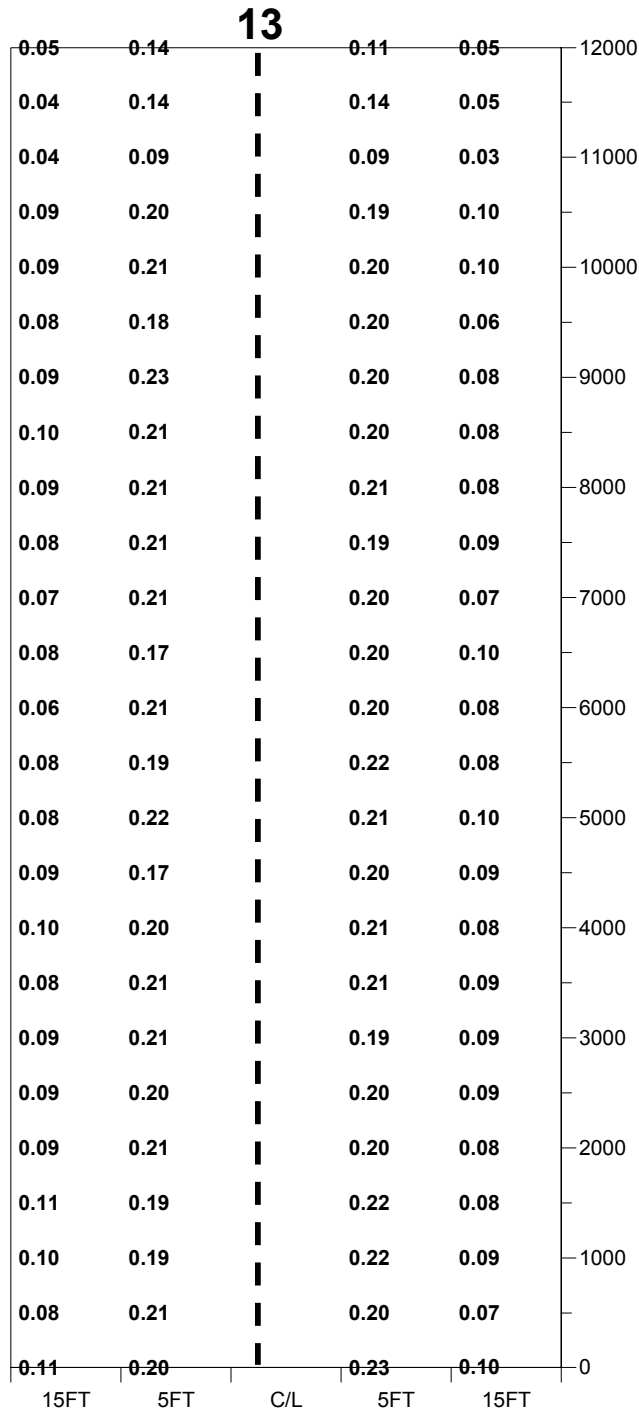
## RAINFALL (INCHES/HOUR) TO FLOOD THE AVERAGE PAVEMENT TEXTURE DEPTH

2. A mathematical model was used to determine the rainfall intensity necessary to cause flooding on the runways. Keep in mind that the model does not consider weather effects like temperature, wind, and evaporation rates, which can significantly change drainage characteristics. The predicted rainfall rate required to flood the runway macrotexture is listed on pages B-3 and B-4 for Runway 13/31 and the Parallel Taxiway, respectively. This model indicates that rainfall rates between about 0.04 to 0.23 inches per hour could flood Runway 13/31 and rainfall rates between about 0.03 to 0.16 inches per hour could flood the Parallel Taxiway.

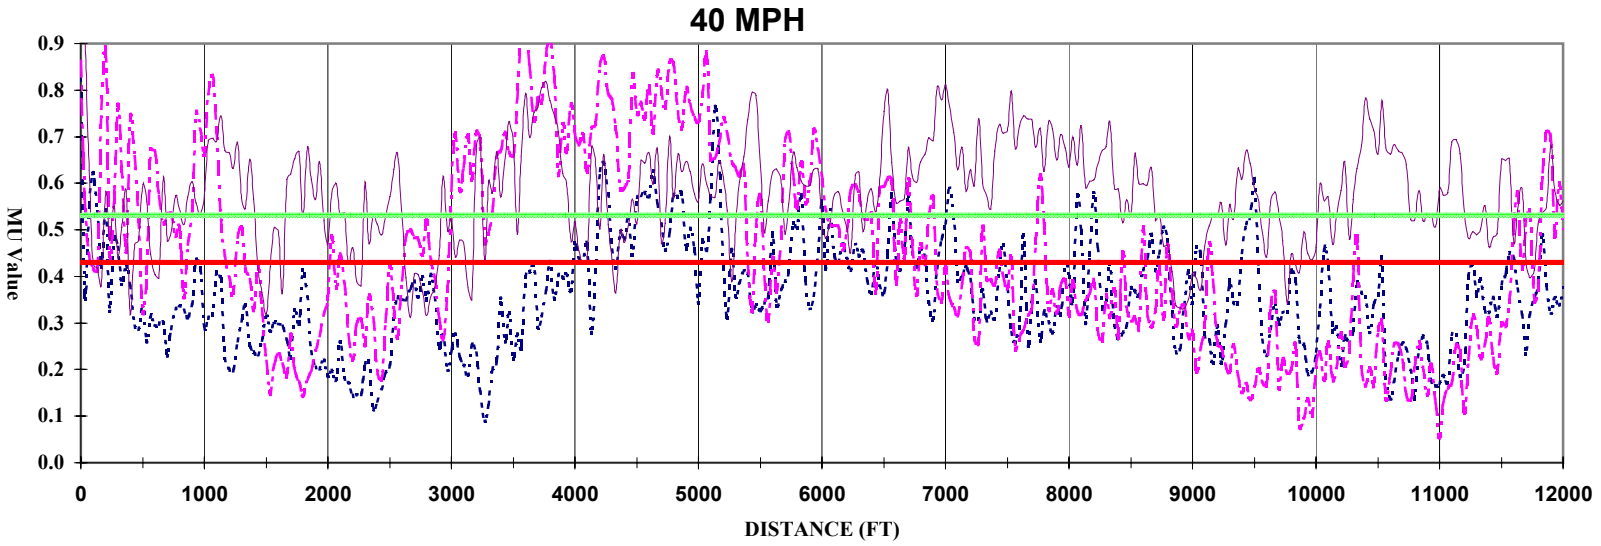
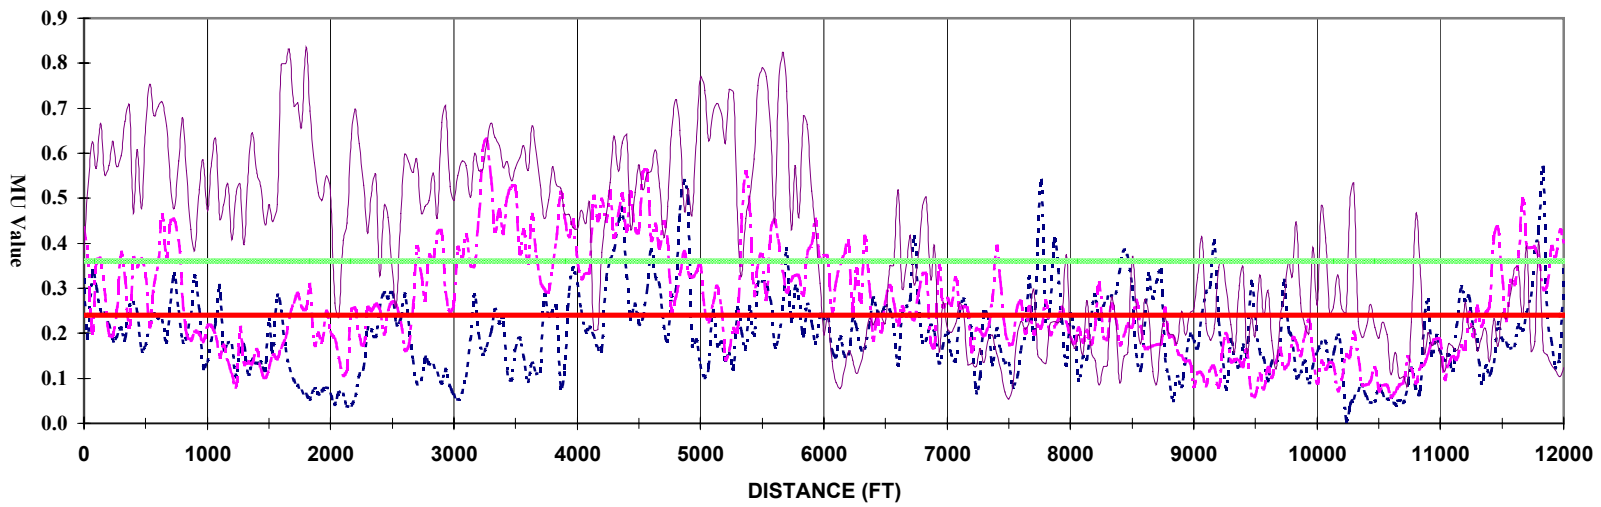
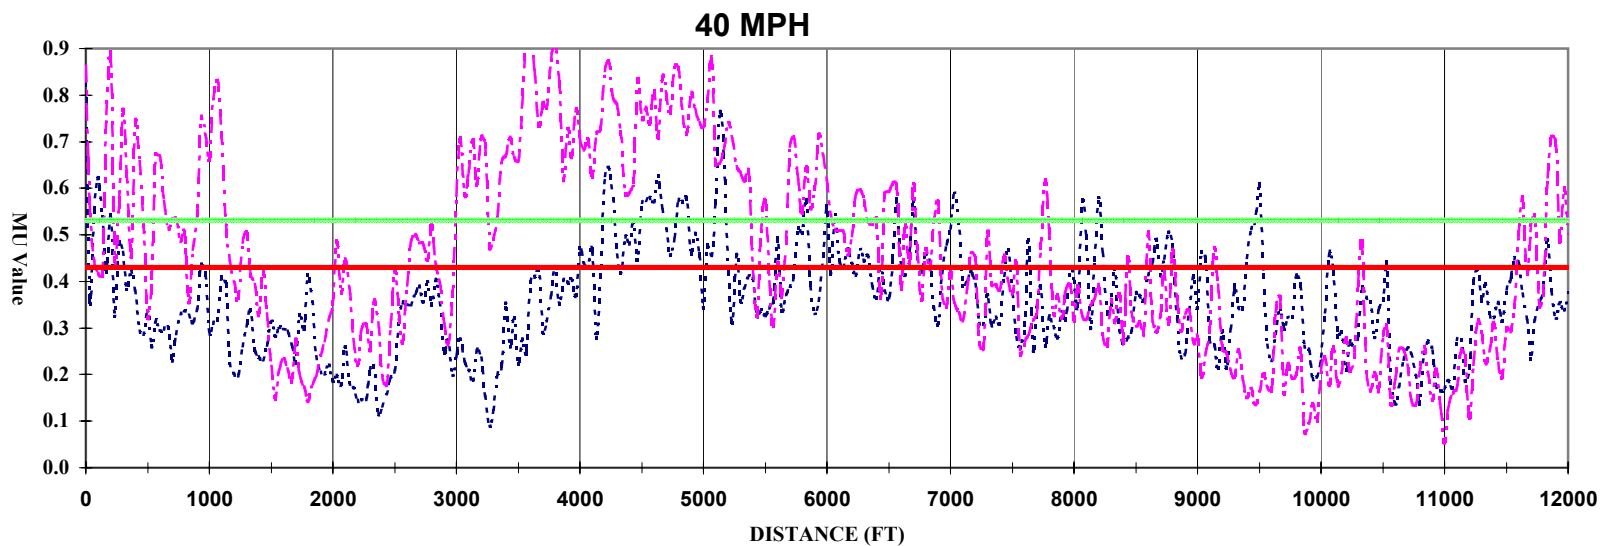
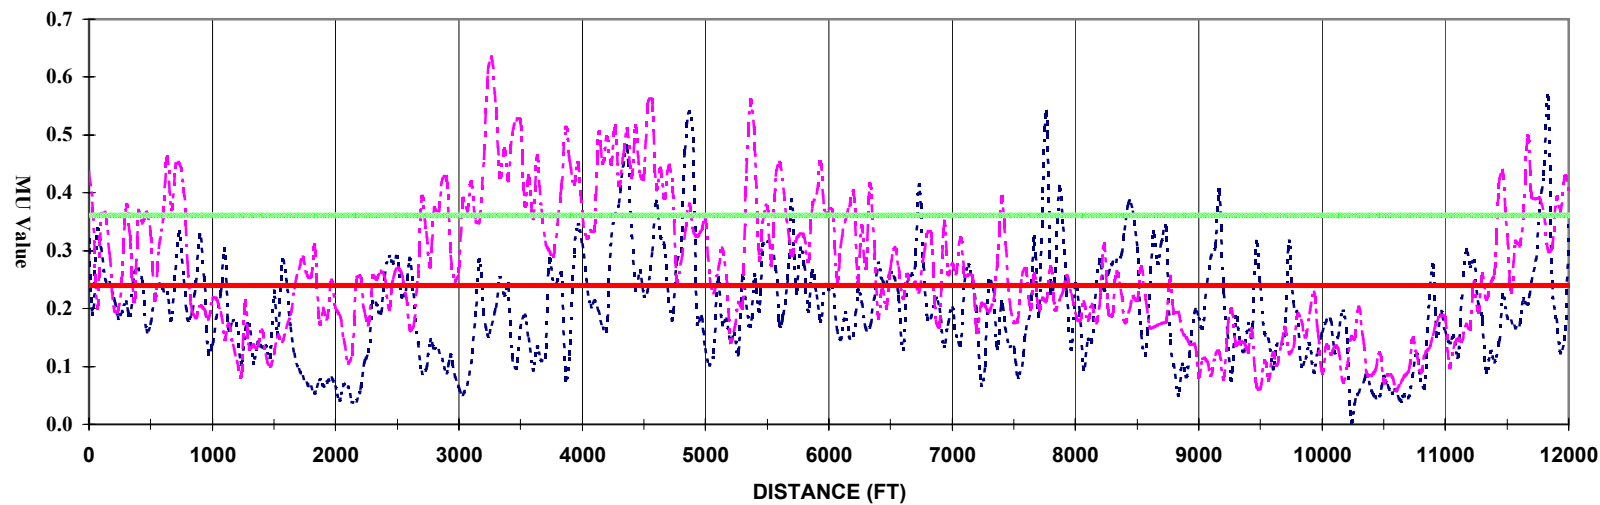
## SELF-WETTING GRIP TESTER FRICTION PLOTS

Runway 13/31: The measured friction values for the runway are illustrated on page C-2 and C-3. Unless otherwise stated, distance remaining values are referenced from the 31 end. The values at the 40-mph testing speed at most locations hover between the planning and action levels or below the action level. The measured values on the left and right of centerline show that the runway surface exhibits significant potential

for hydroplaning. Both touchdown areas and most of the runway interior display friction levels below the action level on the right, left, or both testing sides. The highest friction levels were at 8,000 to 5,000 distance remaining where values oscillated between the planning and action level. The 60-mph test data shows that either one or both sides of the centerline are below the planning level for the entire length of the Runway at all but four points on the chart. Either one or both 60-mph tests show that the data falls beneath the action level for more than 80% of the Runway surface. The edge testing stays above the planning level for the majority of the runway but hovers between the planning and action level in several areas. The edge testing suggests that significant polishing has occurred due to aircraft traffic, rubber removal operations, and soft aggregate in the concrete. **The analysis shows that corrective action should be taken immediately.**

1. Runway 13/31: The surface friction is below the minimum threshold for the majority of the runway. Both touchdown areas and much of the interior section of the Runway have poor friction characteristics. The only section that showed fair friction performance was the section 4,000 to 6,000 feet from the 31 end. The lowest 500-foot average was at 1,000 to 1,500 from the 31 end with a MU value equal to 0.19. This correlates to a RCR of 7.
2. Parallel Taxiway: This surface has a lower average texture depth and displays poorer friction characteristics than the Runway. It should not be used in wet weather conditions. The lowest 500-foot average was at 3,000 to 3,500 feet from the 31 end with a MU value equal to 0.25. This correlates to a RCR of 9.

1. Runway 13/31: Saw transverse grooves along the full length of the Runway. Standard FAA groove configuration is  $\frac{1}{4}$  inch in depth,  $\frac{1}{4}$  inch in width, with  $1\frac{1}{2}$  inch center-to-center spacing. The grooves should be terminated within 10 feet of the runway edge and the grooves shall not be closer than 3 inches or more than 9 inches from transverse joints and not closer than 3 inches from longitudinal joints. This spacing will eliminate damage to joint sealant and prevent premature joint spalling.

2. Runway 13/31: At a minimum, grind the first 3,000 feet of the runway ends. Grinding will improve the overall surface texture and increase the average texture depth of the runway.

3. Following grooving and grinding operations, reseal all joints. High joint seal distress is the most widespread distress on the runway.
4. Runway 13/31: Until grooving is accomplished, recommend runway operations are restricted to emergency operations for at least 23 minutes following a rainfall event.

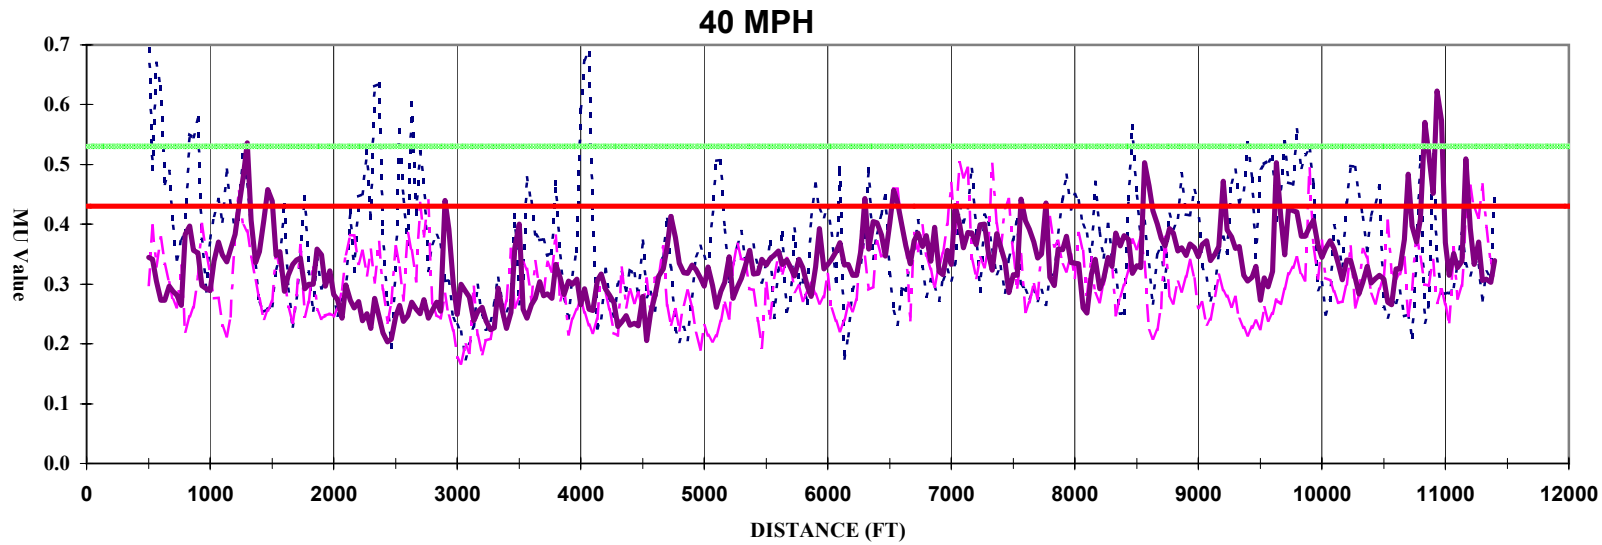
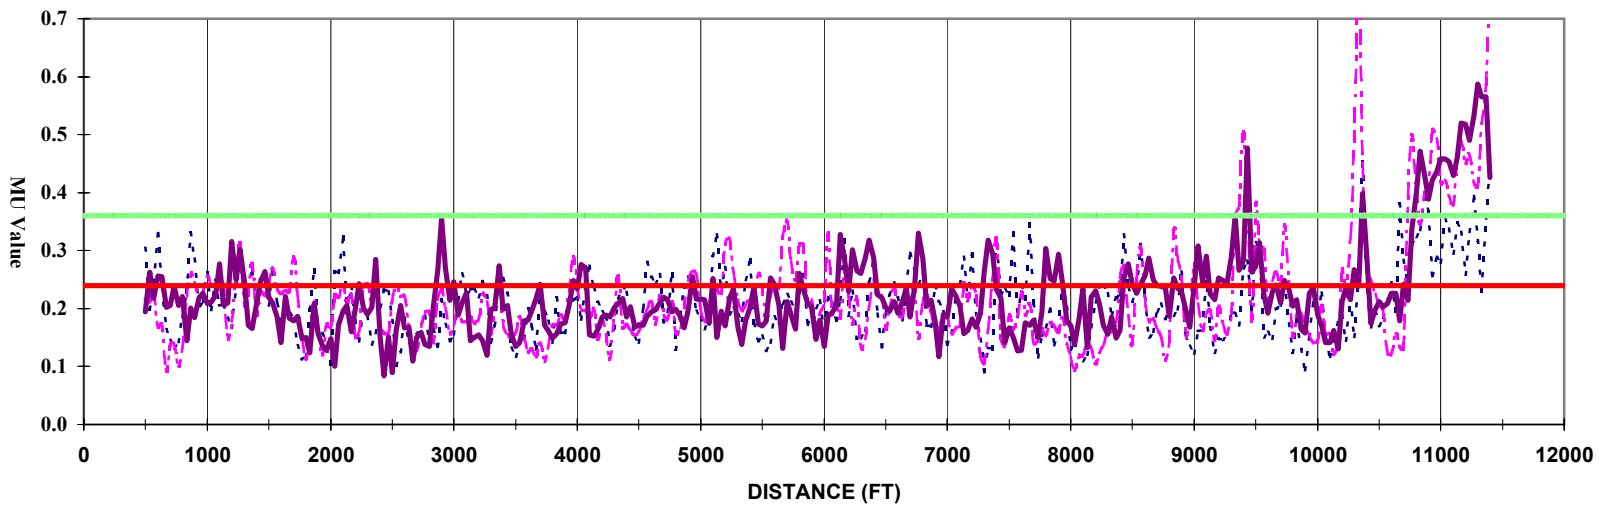
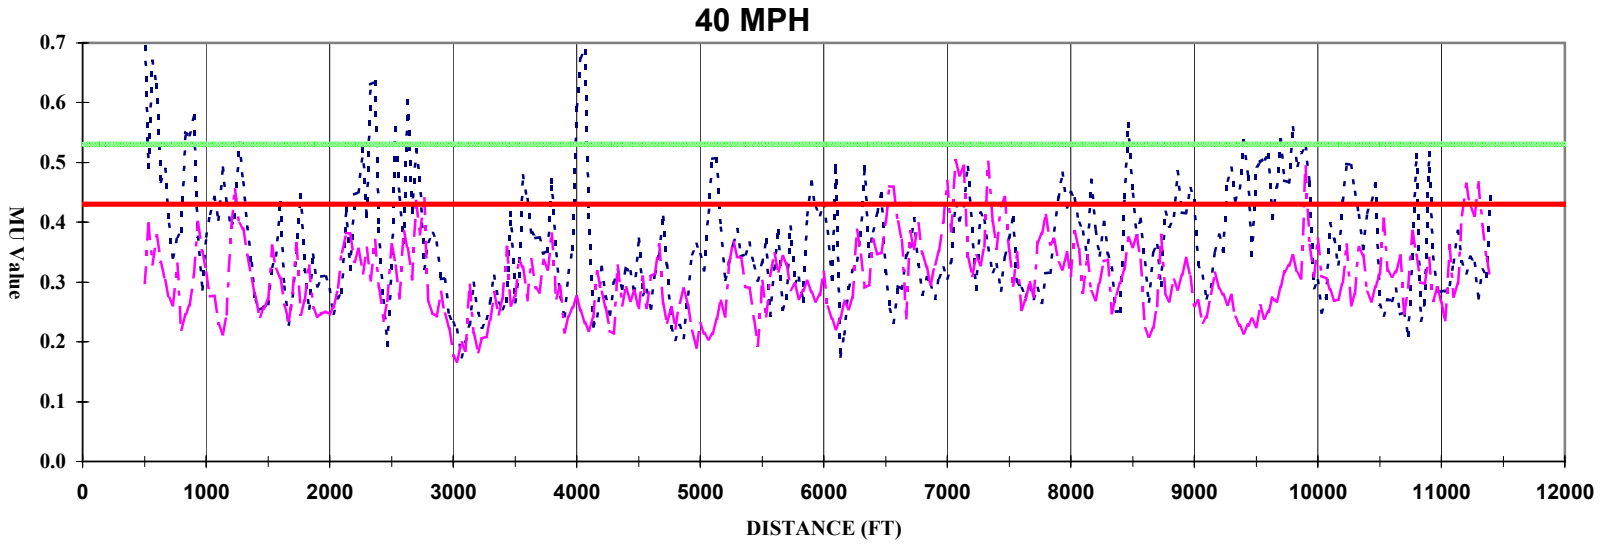
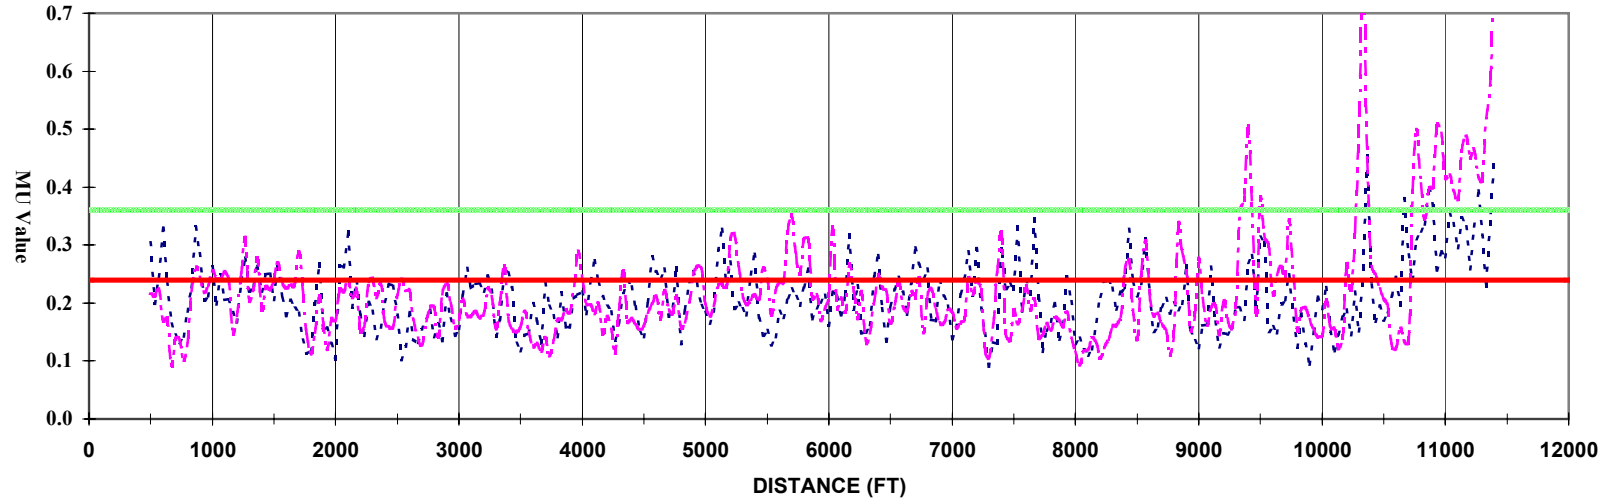
**Diego Garcia Taxiway, BIOT**  
SELF-WETTING GRIP TESTER FRICTION PLOTS

Parallel Taxiway: Since the parallel taxiway does not have overruns, testing started at 11,500 feet and ended at 500 feet from the north end. The measured friction values for the Parallel Taxiway are illustrated on page C-4 and C-5. The values at the 40-mph testing speed are significantly low, and range from 0.2 to the action value of 0.43. Few sections actually reach the zone between the planning and action level. 60-mph tests show the same trend and only reach above the action level during the last 1,000 feet, attributed to the operator slowing the vehicle, not because the pavement had better friction characteristics. The edge testing for both testing speeds mimic the centerline tests showing degradation of surface friction has not occurred. The Parallel Taxiway has poorer friction characteristics than the Runway and should not be used when the surface is wet except under emergency conditions. **If used as a runway, a NOTAM should be issued to restrict use during wet conditions.**

5. Parallel Taxiway: If used as a runway, a NOTAM should be issued restricting use under wet conditions.

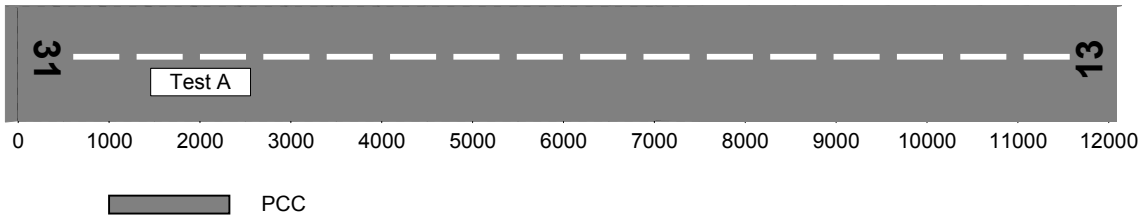
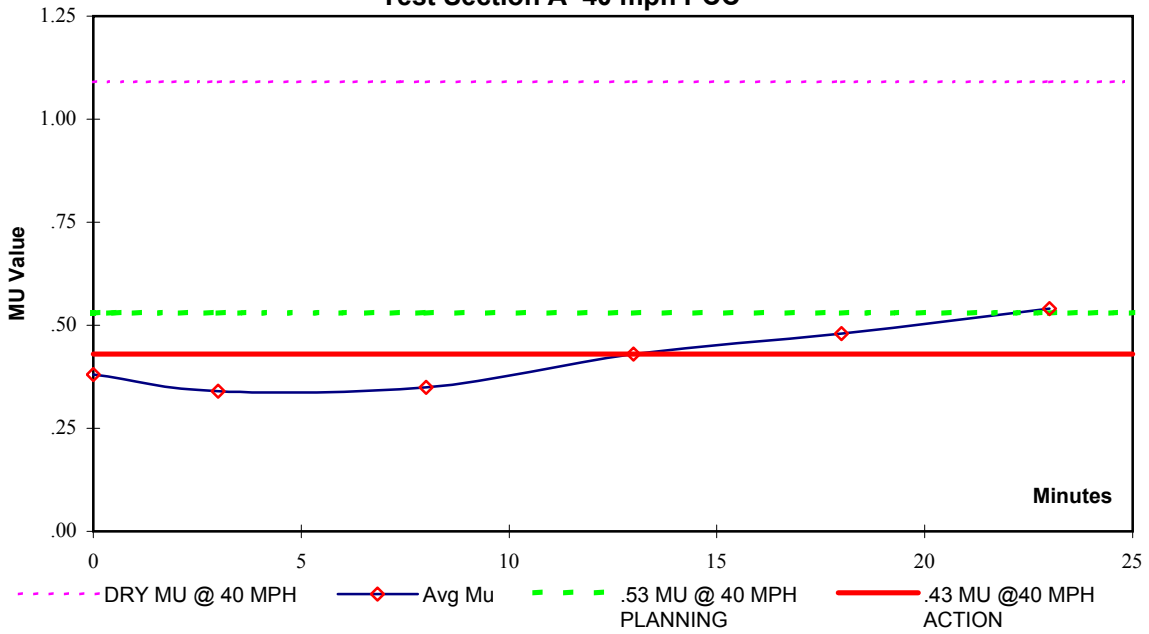
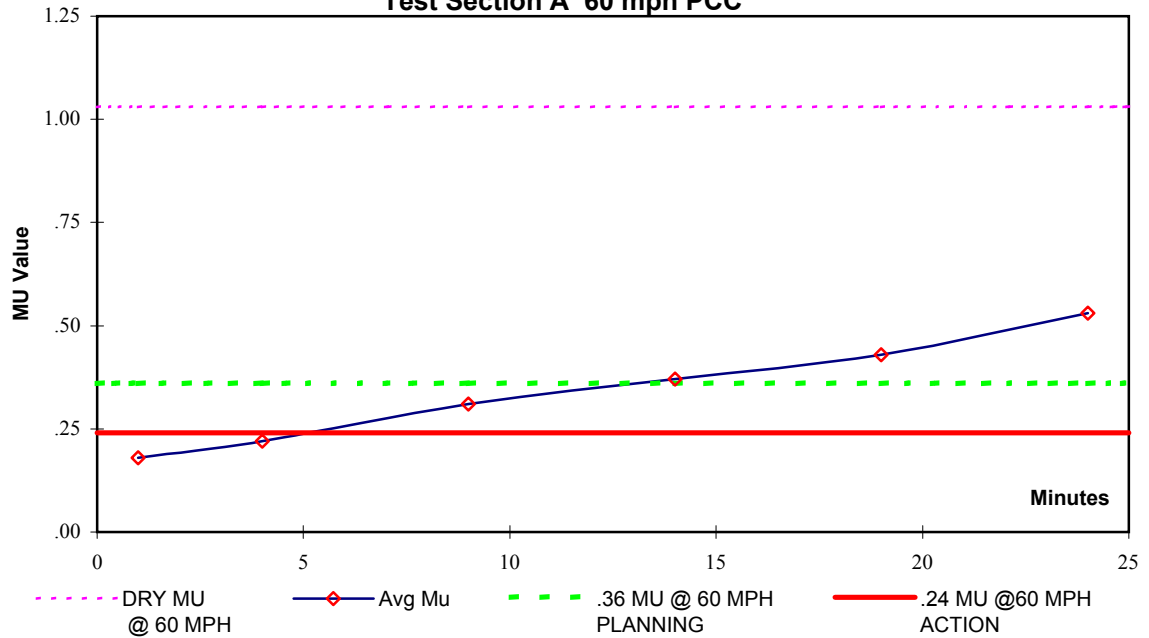
## FLOOD RECOVERY TEST SECTION A

Flood Test A for Runway 13/31 was located 1,500 to 2,500 feet from the 31 end of the runway. The results are illustrated on page D-1. The test section recovered to above the action level in 13 minutes at 40 mph and 6 minutes at 60 mph. Flood Test B was located 5,000 to 6,000 feet from the 31 end of the Runway. The results are illustrated on page D-2 and the test section recovered to above the action level in 5 minutes at 40 mph and 3 minutes at 60 mph. Flood Test C was located 10,000 to 11,000 feet from the 31 end of the Runway. The results are illustrated on page D-3. The test section recovered to above the action level in 15 minutes at 40 mph and 14 minutes at 60 mph. Flood Test C governs the minimum requirement for this Runway; aircraft should not operate on the Runway surface for at least 15 minutes following a high-intensity rainfall event. A more conservative value comes from Flood Test A, where the section recovers to the planning level in 23 minutes.

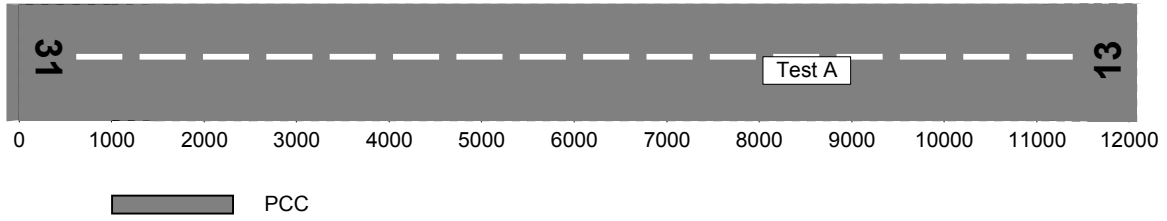
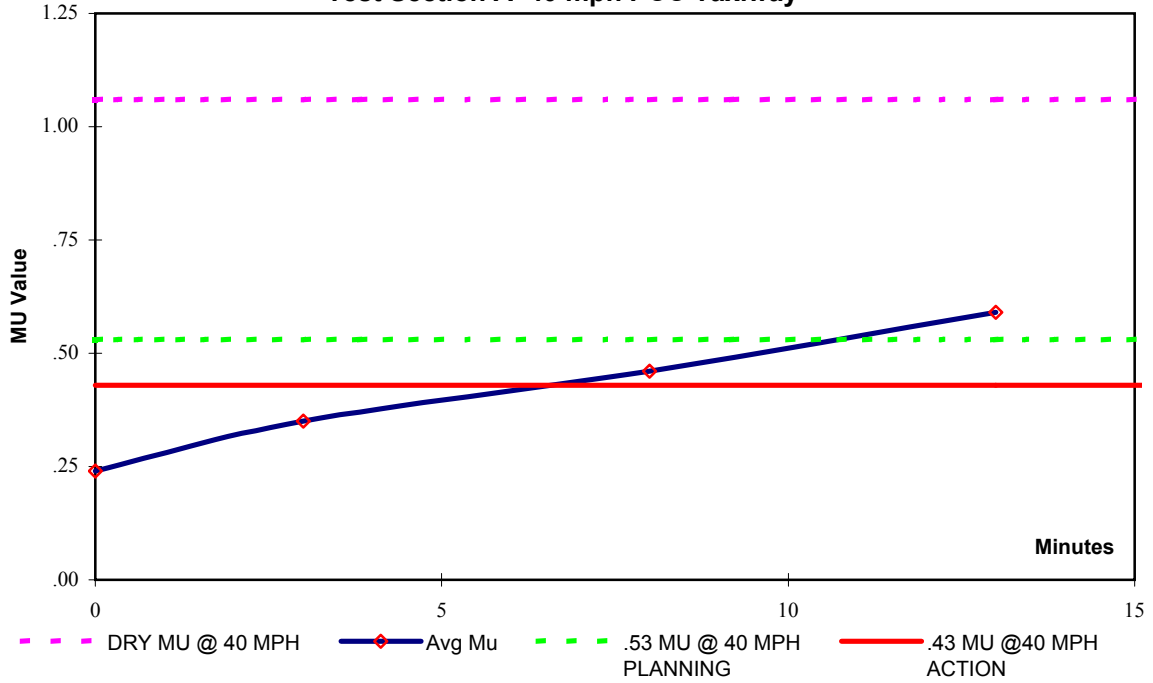
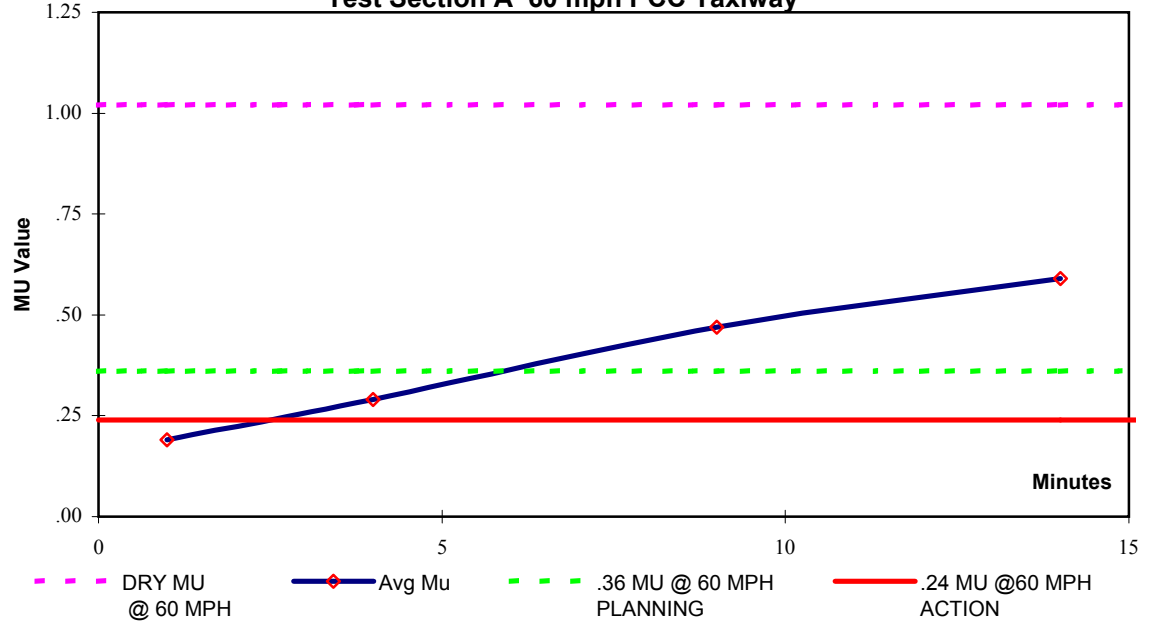
## FLOOD RECOVERY TEST SECTION A

Flood Test A for the Parallel Taxiway was located 8,000 to 9,000 feet from the 31 end and the results are shown on D-4. The test section recovered to above the action level in 7 minutes at 40 mph and 3 minutes at 60 mph. Flood Test B for the Parallel Taxiway was located 3,000 to 4,000 feet from the 31 end and the results are shown on D-5. The test section recovered to above the action level in 6 minutes at 40 mph and almost immediately at 60 mph. The minimum amount of time for aircraft operations on the Parallel Taxiway is 7 minutes, though a more conservative value comes from Flood Test A showing the surface recovers to the planning level in 11 minutes.
